A COLLECTION OF STEEL METALLOGRAPHIES
WITH ILLUSTRATION AND DESCRIPTIONS

Source. Steel Metallography, 1975, pages 1-149.

--Steel Macrostructure and Defects--

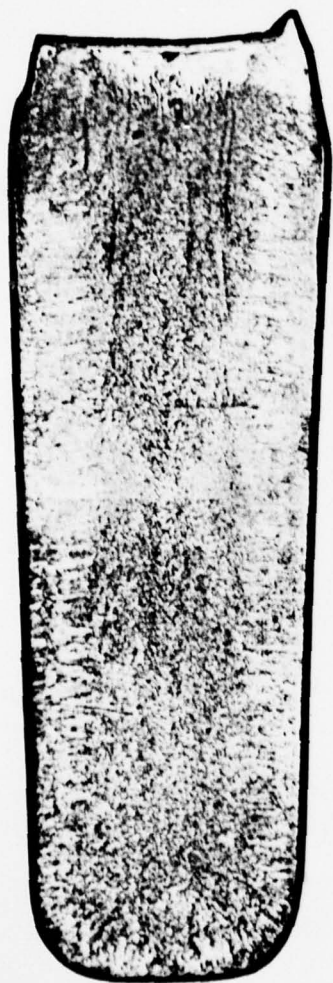
Picture No.	Title	Description
101	The crystal structure and defects of 30CrMnSiNi structural alloy steel ingot	<p>The weight of the ingot is 3 ton, and it is big-end-up with a hot top. The crystalization begins from the mould wall and gradually spreads to the center. From the longitudinal section of the ingot, three crystal zones can be seen. The extremely outside one is a very thin shell layer, which is formed by fine isometric crystals. Next is a rather thick columnar crystal zone and it is formed by coarse and long crystals which stand perpendicular to the mould wall. The one that is connected with the columnar crystal zone is the central zone and it is formed by large isometric grains.</p> <p>In the central zone, there is clear V-shaped segregation. On both sides of the V-shaped segregation, and on the border between the columnar crystal and the central zone, there are some slightly inclined segregation lines, which are usually called inverted V-shaped segregation, and also called A-shaped segregation, "beard" or</p>

Etching agent: 1:1 hydrochloric acid water
solution at 60-70°C.

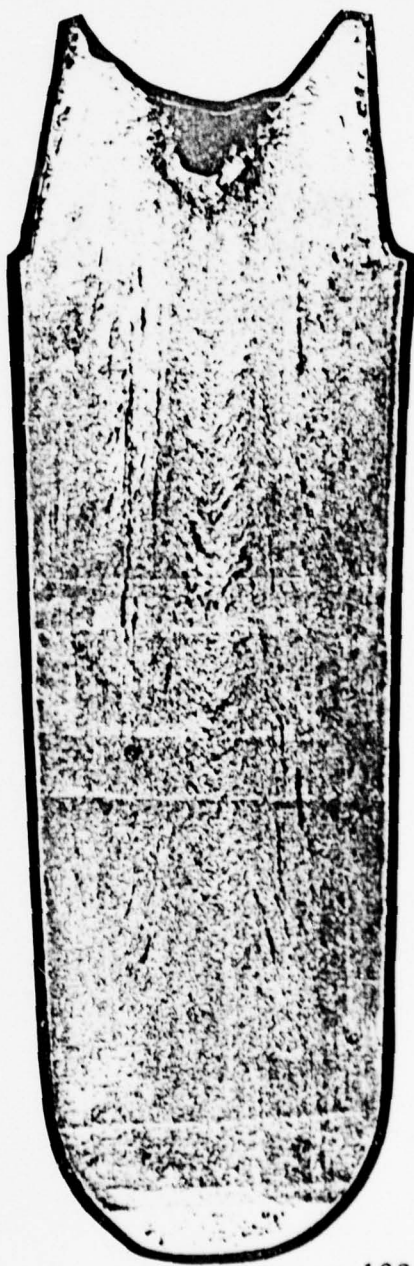
.....		
102	The sulphur print on the longitudinal cross-section of heavy rail steel ingot	The chemical composition of the steel is 0.64%C, 0.22%Si and 0.73%Mn. The weight of the ingot is 5.3 ton, and it is big-end-up with a hot top. As a result of having such sulphur prints, it proves that the sulphur content of the steel in the V-shaped and inverted V-shaped segregation parts is high.

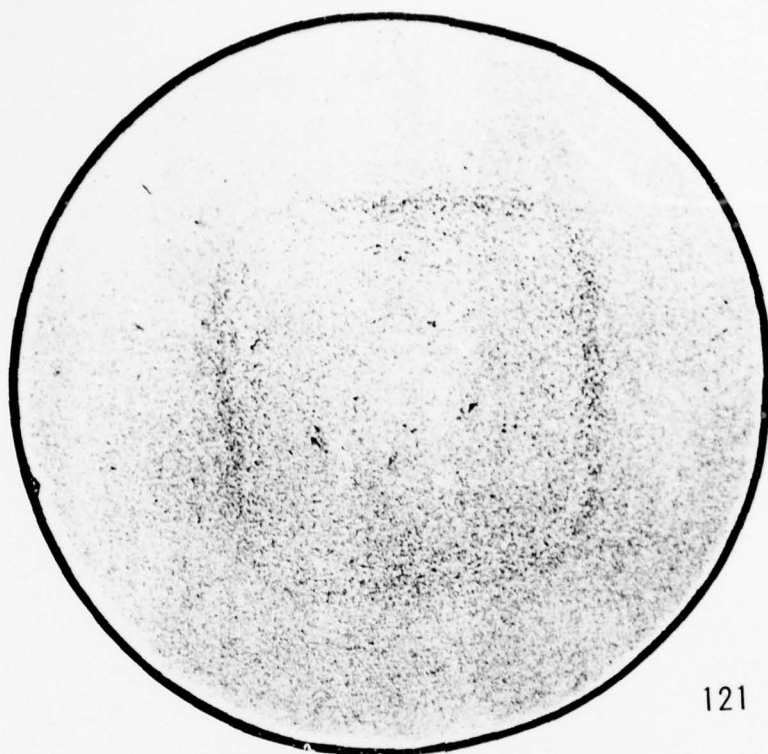
Picture No.	Title	Description
121	Ingot-shaped segregation and spot segregation	<p>Ingot-shaped segregation and spot segregation of 38CrMoAl steel. This transvers testing piece is taken from a part corresponding to the middle-lower part of the steel ingot which has been rolled into a round piece of 200mm. Generally speaking, most of the spot segregation appear on the upper-middle part of a steel ingot and it gradually reduces from upper part downward. And most of the ingot-shaped segregation are at the middle part of a steel ingot and it gradually becomes severe from upper part downward. So at the middle lower part of a steel ingot, there is only ingot-shaped segregation and no spot segregation, and neither of them appears on the tail of ingot.</p> <p>Etching agent: 1:1 hydrochloric acid water solution at 60-70°C.</p> <p>Multiple: 1:2</p>
122	Spot segregation	<p>Spot segregation of 38CrMoAl structural alloy steel. Spot segregation on the hot acid etching transverse testing piece, according</p>

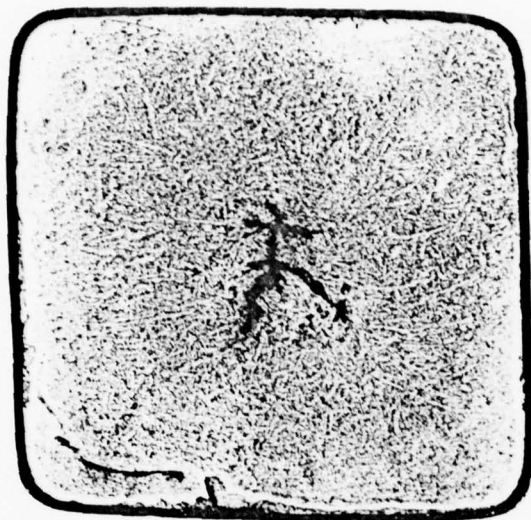
Picture No.	Title	Description
128	Shrinkage cavity remnant	<p>Shrinkage cavity remnant in a steel billet of GCr15 bearing steel. There are overturned skin and other defects on the edge of the billet. The shrinkage cavity remnant at the central part of the hot acid etching transverse testing piece (perhaps because of the effect of hot working deformation, it moves close to the central part) appears to be wrinkle cracks, if the crop end of the billet is too few, they can even become macroscopic hollow. In the neighbouring areas of the shrinkage cavity remnant, there generally are aggregation of impurity inclusion, and unsolidness or segregation. This is the basis to differentiate shrinkage cavity remnant from internal cracks.</p>

Etching agent: 1:1 hydrochloric acid
water solution at
60-70°C.

Multiple: 1:1
.....

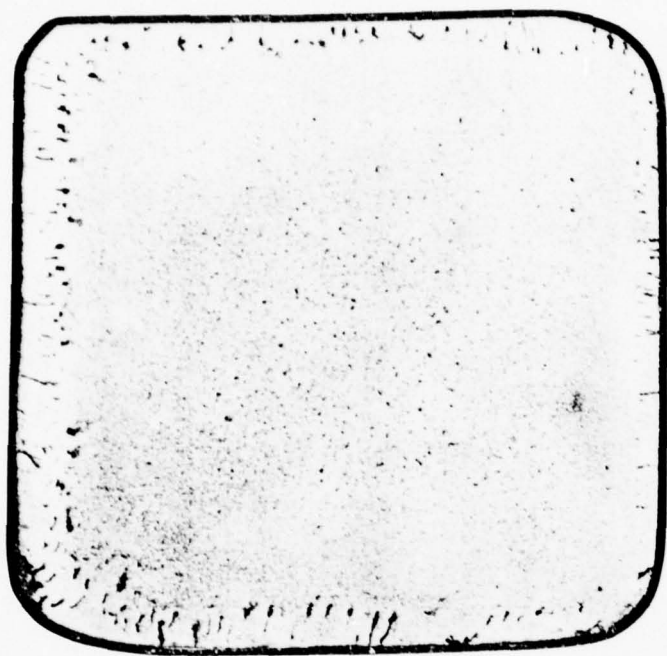
Picture No.	Title	Description
136	Underneath -skin bubble	<p>The underneath-skin bubble in 20 steel billet. Part of the bubbles were burned open and exposed on the surface of the billet, so they became a crack. Besides these underneath-skin bubbles, there is defect of unsolidness in the billet.</p> <p>Etching agent: 1:1 hydrochloric acid water solution at 60-70°C.</p> <p>Multiple: 1:1</p> <p>.....</p>
137	White spots	<p>At the longitudinal fracture of 50 steel billet, the white spots became coarse crystal which is of the shape of silvery bright oval dots, and the inner walls of the spots have the characteristics of coarse grains.</p> <p>Etching agent: 1:1 hydrochloric acid water solution at 60-70°C.</p> <p>Multiple: 1:2</p> <p>.....</p>

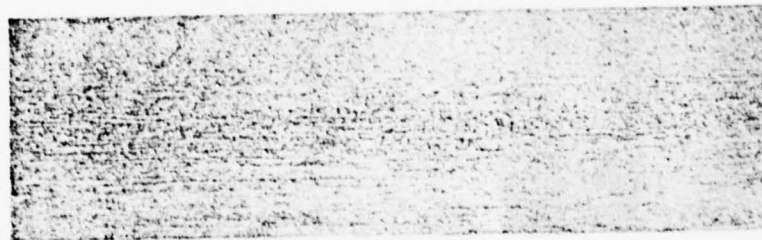
Picture No.	Title	Description
144	White spots	<p>White spots on the longitudinal section of a rail end, and the heavy rail does not have gradual cooling after rolling (picture above). There is no white spot on the longitudinal section of the rail end after gradual cooling (picture below).</p> <p>Etching agent: L:l hydrochloric acid water solution at at 60-70°C.</p> <p>Multiple: Approximately 1:1.3</p>
145	White spots	<p>Small white spots (as arrow pointing) on a billet of train wheel steel (corresponding to 65 steel).</p> <p>Etching agent: 1:1 hydrochloric acid water solution at 60-70°C.</p> <p>Multiple: 1:1</p>

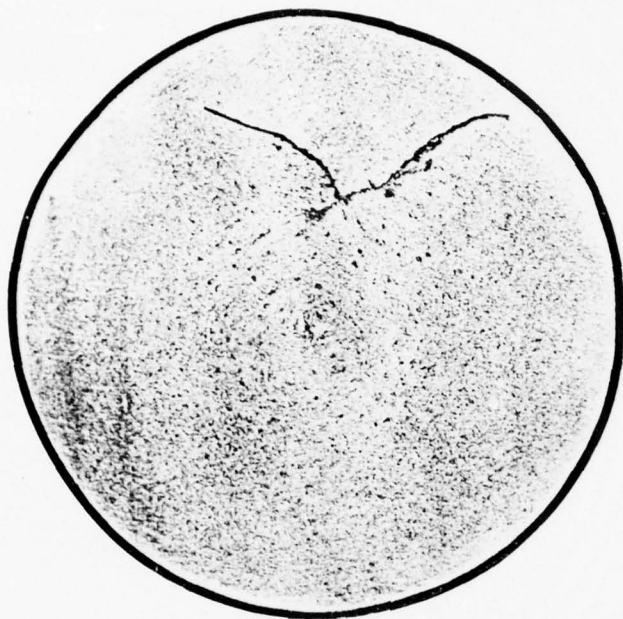
Picture No.	Title	Description
154	Overturnd skin	<p>Overturnd skin (also called titanium shell) on a round billet of 18CrMnTi structural alloy steel. The form of curling skin of this kind of steel is different from that of other kind of steel. It often appears in a shape of fine strip, but the reason of its coming into being is all the same.</p> <p>Etching agent: 1:1 hydrochloric acid water solution at 60-70°C.</p> <p>Multiple: 1:1</p>
155	Overturnd skin	<p>Underneath surface overturnd skin of 34CrMo structural alloy steel. Underneath skin surface overturnd refers to that of which the position is very close to the surface of the steel material.</p> <p>Etching agent: 1:1 hydrochloric acid water solution at 60-70°C.</p> <p>Multiple: 1:3.5</p>

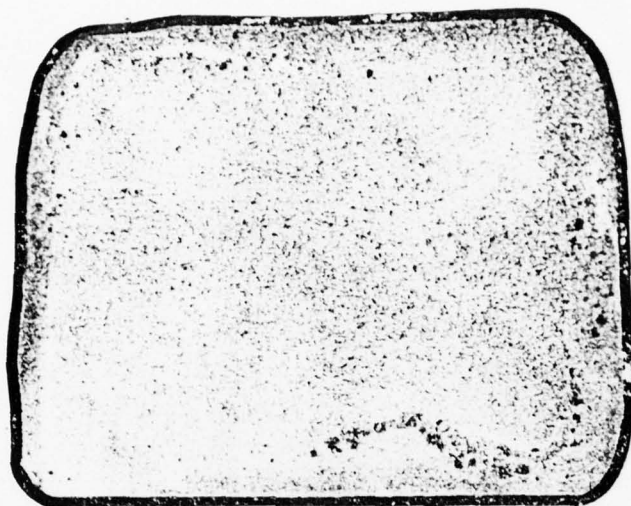
Picture No.	Title	Description
156	Overtuened skin	<p>The overturned skin in 45 steel. At the left upper corner, the overturned skin appears to be a white bright band, and around it there are pores, which were left after the impurity inclusion was eaten away by acid etching. At the right lower corner, the overturned skin is of the shape of black curved band. In the black band and its vicinity, there are some impurity inclusions. During ingot casting, there is an oxide film floating on the surface of steel liquid. In pouring, the film goes down into the liquid, and then it became an overturned skin in or on the cast ingot.</p> <p>Etching agent: 1:1 hydrochloric acid water solution at 60-70°C.</p>

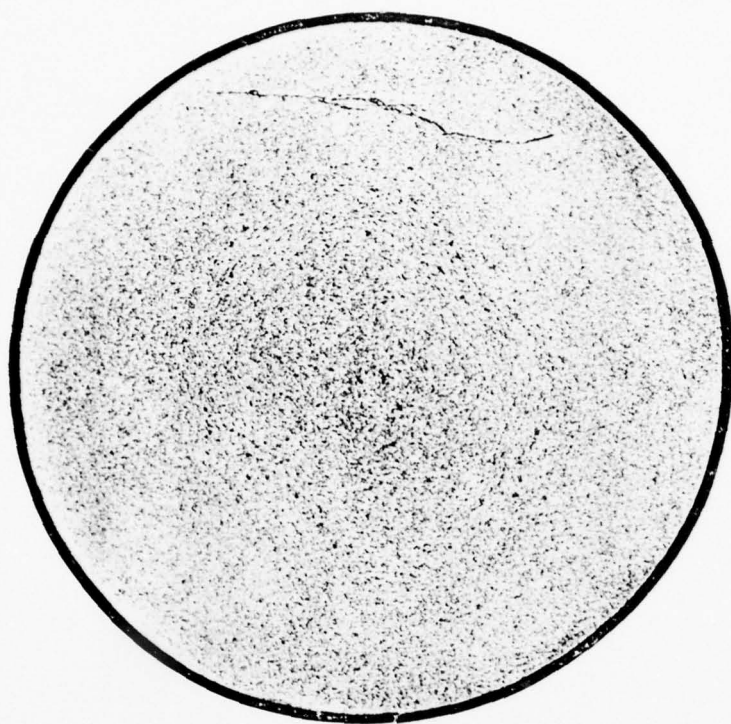
Picture No	Title	Description
158	Overturnd skin	Overturnd skin in a billet of 30CrMnSi structural alloy steel. Etching agent: 1:1 hydrochloric acid water solution at 60-70°C. Multiple: 1:1.2
159	Overturnd skin	The form of overturnd skin on the longitudinal testing piece of an axial billet of 45 steel. The skin is like a black strip. Etching agent: 1:1 hydrochloric acid water solution at 60-70°C. Multiple: 1:1.7

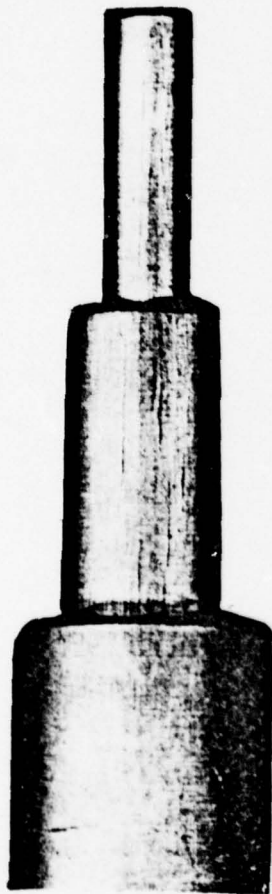
Picture No.	Title	Description
171	Incipient crack	<p>Incipient crack on the pagoda-shaped testing piece of 40CrNiMoV structural alloy steel. Incipient crack is made by non-metal inclusion or air in the steel.</p> <p>Etching agent: 1:1 hydrochloric acid water solution at 60-70°C.</p> <p>Multiple: 1:1</p> <p>.....</p>
172	Axis center carbon segregation	<p>Carbon segregation in a billet of 10 steel, and the segregation appears in the area close to the top of the ingot. It was caused by the fact that when the casting was shielded by graphite slag, carbon entered into the top of the ingot.</p> <p>Etching agent: 1:1 hydrochloric acid water solution at 60-70°C</p> <p>Multiple: 1:1</p> <p>.....</p>
173	Axis center carbon segregation	<p>Carbon segregation in a billet of 20 steel, and the segregation appears close to the top of the ingot. It was caused by</p>

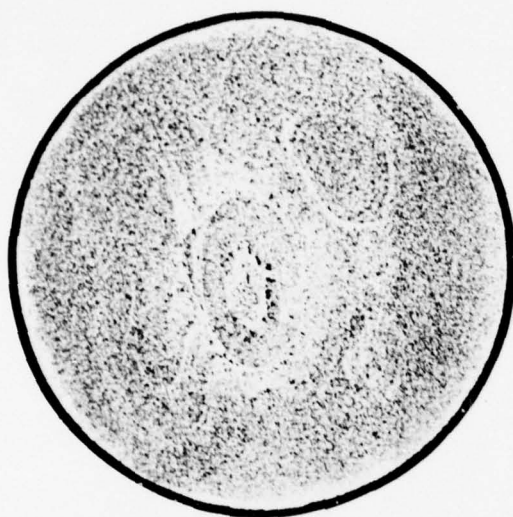
Picture No.	Title	Description
174	Negative segregation	<p>Negative segregation on the tail of an ingot of 30SiMnMoV structural alloy steel. On a hot acid etching transverse testing piece, negative segregation appears in the shape of either oval or irregular white or black band. The difference between negative segregation and overturned skin is that in the vicinity of the band there is no inclusion, and at the same time, the C and S contents are lower than that in the composition of ingot. The reason of producing this kind of defect is not yet known, nevertheless, it can be avoided by increase the steel liquid temperature, pouring faster, especially at the beginning of pouring or changing the shape of the die bottom.</p> <p>Etching agent: 1:1 hydrochloric acid water solution at 60-70°C.</p> <p>Multiple: 1:1</p>
175	Edge coarse crystal	<p>DTI pure steel ingot. if the control of heating is not appropriate, there will</p>

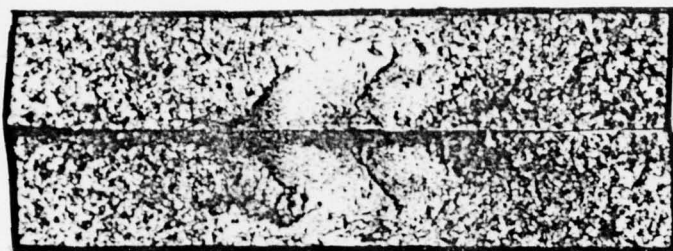
Picture No.	Title	Description
178	Edge	The form of edge coarse crystal at
179	coarse crystal	the fracture on a forge billet of 25Cr3Mo steel (picture 178). The coarse crystal is of strong metal brightness. Maintaining temperature of 920°C for some time, then after heating, the coarse crystal will basically disappear (picture 179).
Etching agent: 1:1 hydrochloric acid water solution at 60-70°C.		
Multiple: 1:1		
180	Coarse crystal	Coarse crystal seen at the fracture on a tube of Cr25 rust-proof steel.

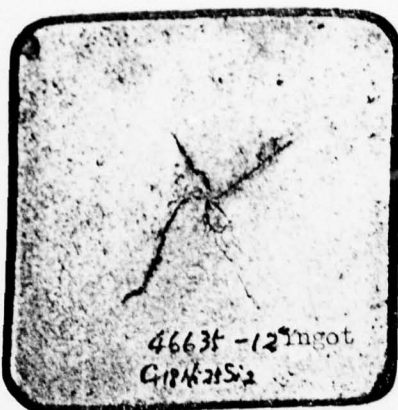
Picture No.	Title	Description
181	Forge crack	<p>Forge crack in a billet of Cr18Ni25Si2 heat resistant steel. Most of the crack appear at the axial part. When there is only one strand of crack, it always runs along a diagonal direction, when they are two, they make a cruciform and when they are more than two, they radiate out from the axis center.</p> <p>Etching agent: 1:1 hydrochloric acid water solution at 60-70°C.</p>
182	Forge crack	<p>The form of forge crack at a fracture when a forge billet of W18Cr4V high speed steel is broken along the crack. The crack is grey in color and there is no oxidizing happening. Because when the billet is broken, the crack is not completely open, so on the fracture, there are a few crystal-like strips.</p>
183	Non-metal inclusion	<p>The form of non-metal inclusion at the fracture of a billet of 12CrNi structural alloy steel. On the longitudinal fracture, the inclusion is of the shape of fine strip.</p>

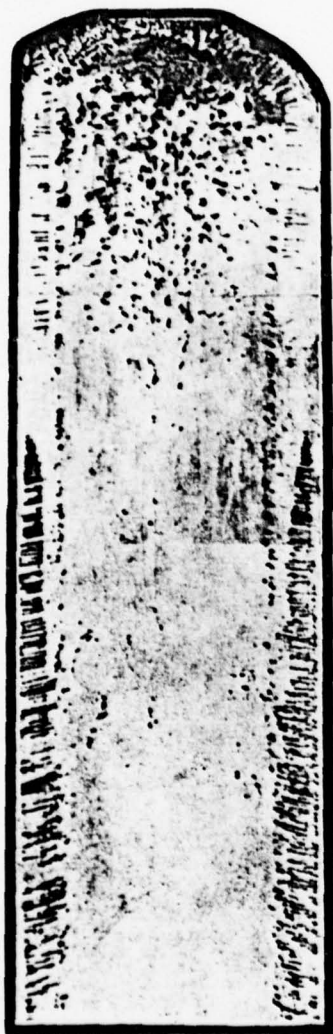
Picture No.	Title	Description
201	The structure and sulphur	The structure (picture 201) and sulphur
202	print of an open ingot of open steel	print (picture 202) of an open ingot of B3F steel. The structure of the longitudinal section of the ingot is of the following few layers: The outmost layer is a solid and hard shell, which contains no bubble. The thickness or thinness of this layer is determined by the condition of smelting and casting. Inside the hard shell, there is a layer of honeycomb bubbles. On this layer scatter many long strip-like bubbles, and the long axis of the bubble is perpendicular to the mould wall and stretches from the bottom of the ingot to its central part. Inside the honeycomb bubble layer, there is a layer of secondary bubbles.

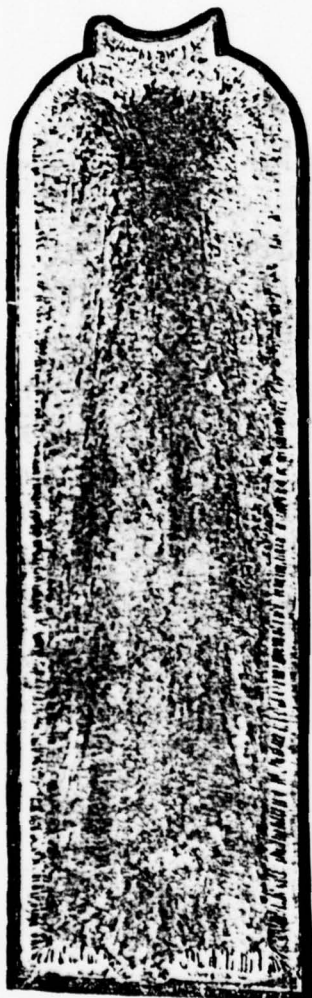
Picture No.	Title	Description
203	The structure and sulphur	The structure (picture 203) and sulphur print (picture 204) of a 7.26 ton bottle-shaped ingot of B3F steel. From the structure of the longitudinal cross-section of the ingot, it can be seen that the thickness of the ingot shell is 20-30 mm and thickness increases gradually from down up. The distribution of the honeycomb bubbles is different from that of the open steel ingot, the bubbles scatter over the whole length including the round arc part at the head, and their body is shorter than those on the open steel ingot. The latter is generally 70-100 mm while the former is about 25-45mm, and they gradually become short from down up. The secondary bubbles are not clear. The liquid extract concentrates in an area which constitutes 6-16% of the top.
204	print of a bottle-shaped ingot of open steel

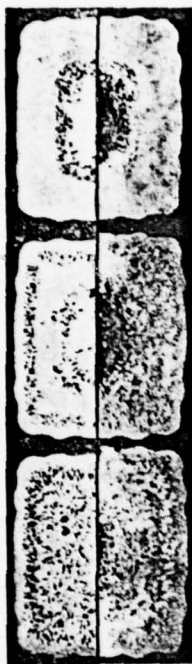
Picture No.	Title	Description
205	The structure and sulphur print of an open steel ingot	The structure seen on the longitudinal cross-section of an open ingot of open steel, which contains 0.09% C. From down up at a distance of 25%, 50% and 75% from the bottom, there are three not-acid--corroded testing pieces (left half) and sulphur prints (right half). The former illustrates the distribution of various kinds of bubbles and the latter illustrates the distribution of sulphide from surface to the center of the ingot.
206	Honeycomb bubbles	Honeycomb bubbles on the transverse cross-section of the middle and lower part of open steel. Etching agent: 1:1 hydrochloric acid water solution at 60-70°C.
207	Silicon segregation	When B3F steel ingot has chemical sealing of its top by using silicon iron, some silicon enters into the honeycomb bubbles. Etching agent: 1:1 hydrochloric acid water solution at 60-70°C. Multiple: 1:2.5

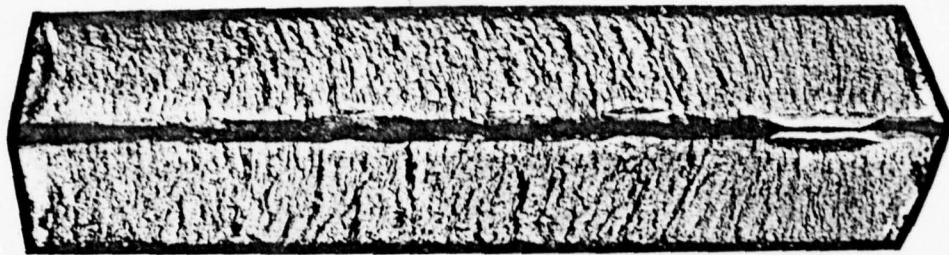
Picture No.	Title	Desxription
503	Wood-ring fracture	Less severe wood-ring fracture (picture above) and severe wood-ring fracture (picture below) seen in 18CrNiW steel under condition of modification. The fracture shows concavo-convex wood rings without metal brightness, but sometimes there are bright lines with various length. It has been considered that when the non-metal inclusion is high in the steel, the wood rings will be severe, and that the width of the wood-ring region is closely related to the width of the region of ingot-shaped segregation.
504	Wood-ring fracture	Wood-ring fracture seen in 18CrNiW steel.

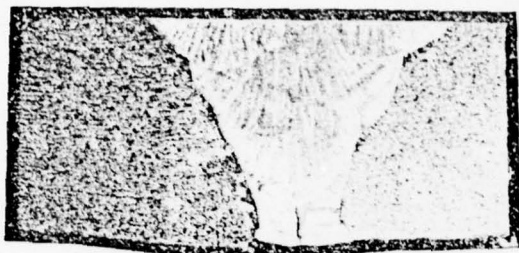
Picture No.	Title	Description
632	Crack of manual electro-arc welding	<p>Welding of No.20 furnace steel and Cr16Ni36 stainless steel.</p> <p>Crack at foot part of welding seam.</p> <p>Etching agent: Hydrochloric acid 50ml, nitric acid 5ml, potassium bichromate 2.5g, water 50ml, mix together and heating to 50°C, hot etching.</p>
633	Crack of automatic welding on thick plate	<p>115mm thick plate of 18MnMoNb steel, welding wire H08Mn2MoA, welding agent 250.</p> <p>Heating to 640°C after welding and temperature retention for 5 hours, then air cooling.</p>

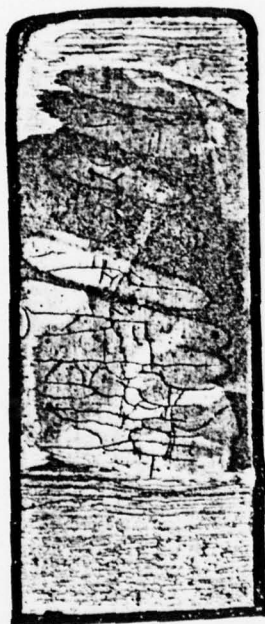
Picture No.	Title	Description
701	Cutting defects	Cracks and structural changes made at the time when a round billet of 60Si2 spring steel is cut with a sand-wheel-blade and partially overheated.
702	Cutting defects	Black circles made at the time when a round billet of GCr15 bearing steel is cut with a sand-wheel-blade and partially overheated. Etching agent: 1:1 hydrochloric acid water solution at 60-70°C. Multiple: 1:1.3
703	Cutting defects	Cracks made at the time when a round billet of GCr15 bearing steel is cut with a sand-wheel-blade and the cooling is not appropriate. Etching agent: 1:1 hydrochloric acid water solution at 60-70°C. Multiple: 1:1.4
